Progress Report
August 1, 1968 through January 31, 1969

THE ADHERENCE OF PORCELAIN ENAMEL TO ALUMINUM

Albert L. Gugeler
Research Associate

Sponsored by
Ferro Corp.

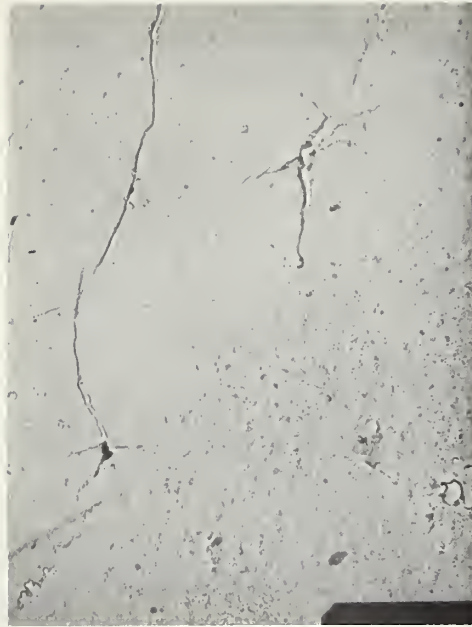
Fig. #3 Prefired and enameled 1100 alloy
175° taper section - anodized after polishing
4 KX

Another method used in electron microscopy was to anodize the polished cross sections prior to replicating. This was done on 175° taper sections, with an anodizing bath of 16% H_2SO_4 , 70°F and 15 volts. The anodizing time was five and ten minutes, with ten minutes appearing better. However, chippage of the thin porcelain enamel wedge was again encountered in the replicating procedure. Only preheated and enameled 1100 (excellent spall resistance) and 5154 prefired and enameled (extremely poor spall resistance) were examined. Fig. #3 is of 1100, anodized for ten minutes. The original interface runs diagonally from the lower left corner to the upper right corner. Below and to the right of this line is the aluminum surface exposed to the anodizing bath. The smooth area on the other side of the line represents unanodized aluminum which has been exposed by the removal of the thin enamel wedge in the replica stripping step. Fig. #4 is another micrograph of 1100 with the same treatment. Again the porcelain enamel has been stripped back from the original interface.

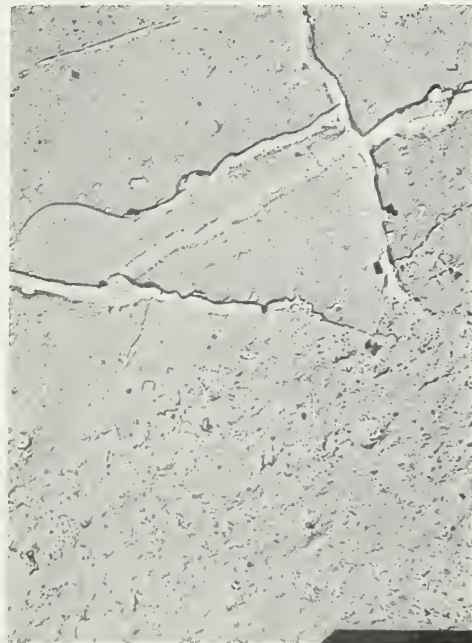
Fig. #4 Prefired and enameled 1100 alloy
175° taper section - anodized after polishing
8 KX

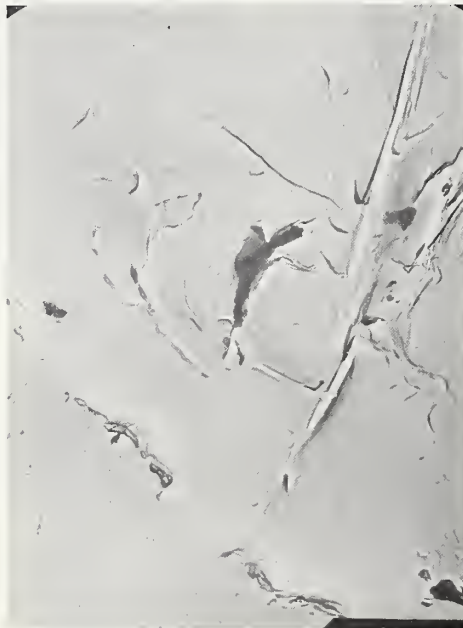
Fig. #6 Prefired and enameled 5154 alloy
175° taper section - anodized after polishing
4 KX

Figs. #5 and #6 are of 5154 after the same anodizing and sample preparation techniques. Again the porcelain enamel has been stripped back from the original interface, making interpretation somewhat more difficult. Note again, however, that samples such as this one of 5154 show a different type of interface than samples which do not spall.

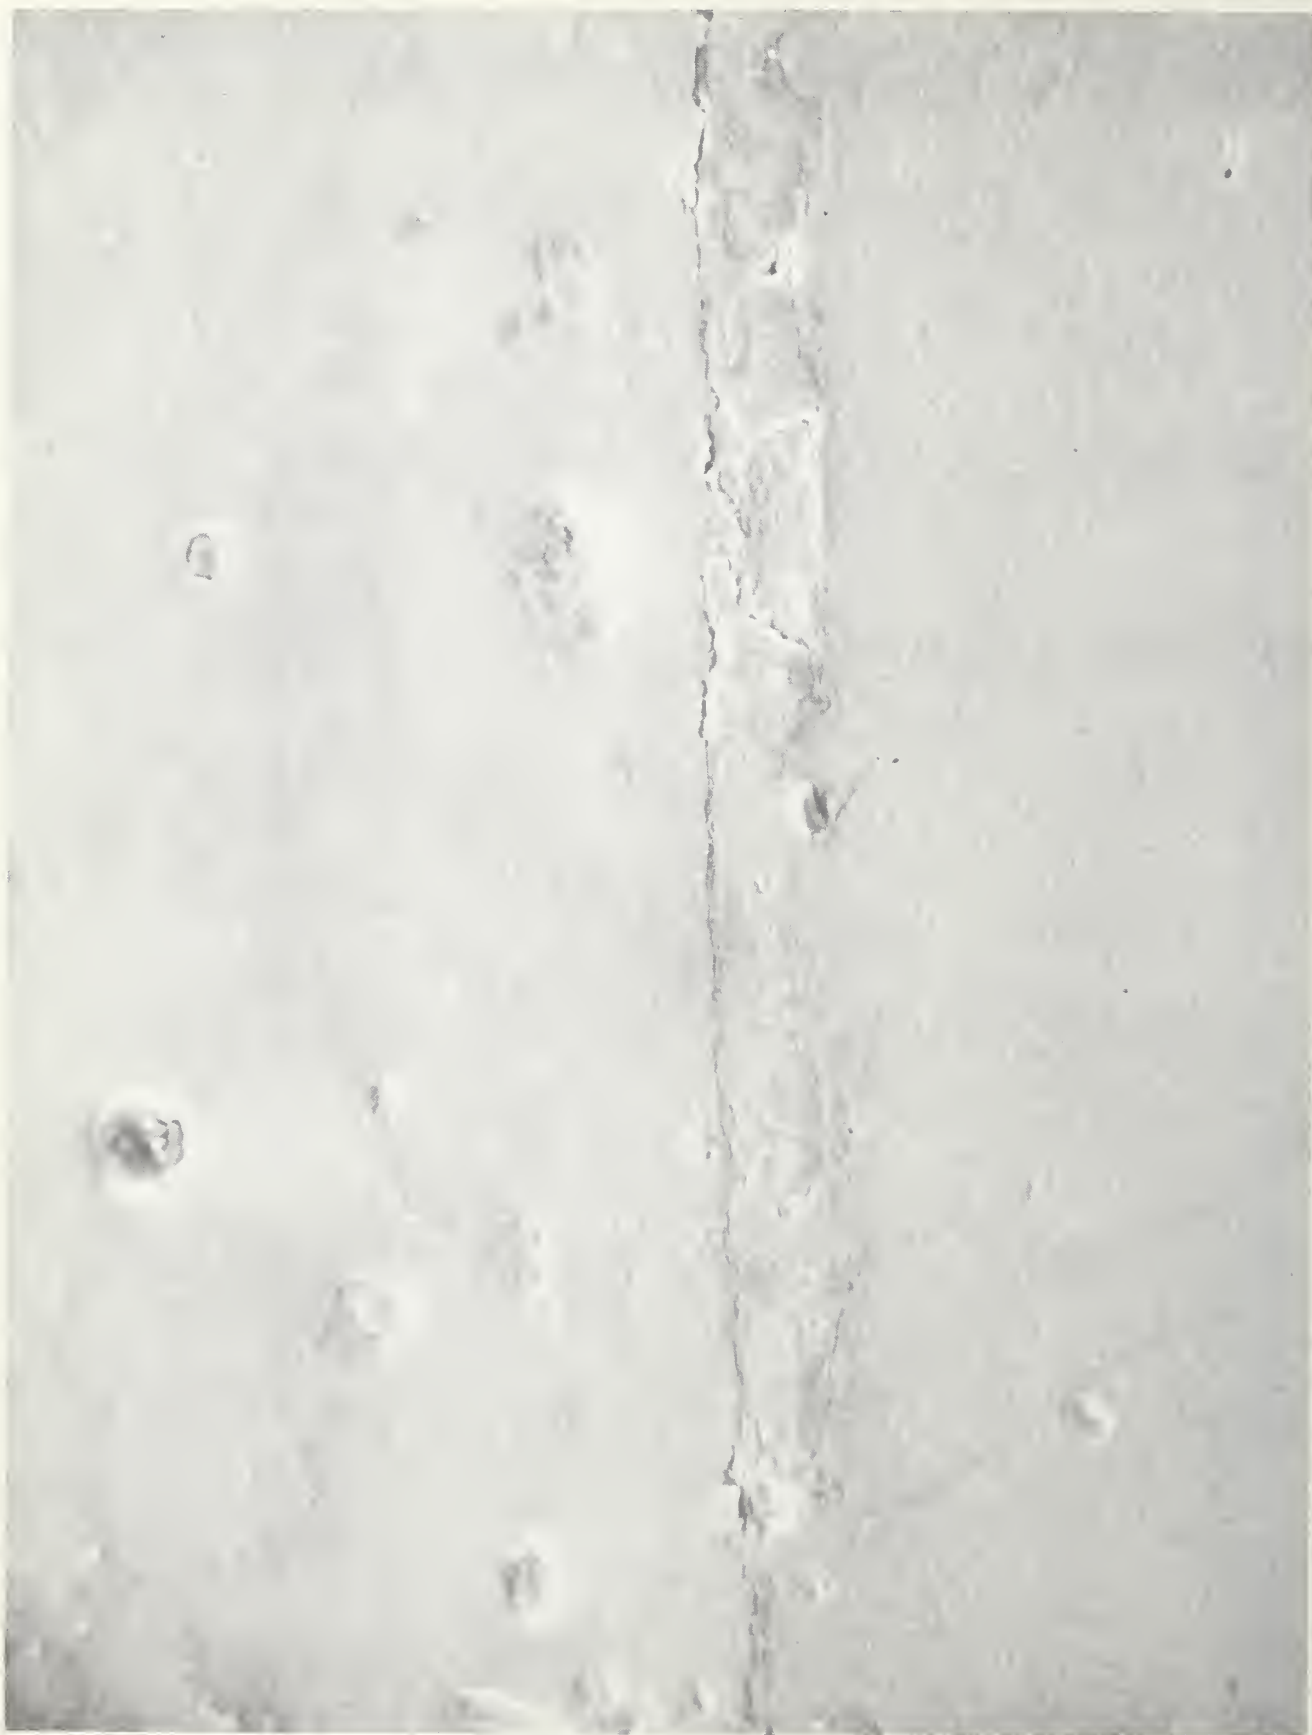
Fig. #8 Prefired and enameled 5154
Scanning electron microscope 1,642X

Fig. #7 is a scanning electron micrograph of the 1100 sample, and Fig. #8 is of 5154. Both samples were etched for 10 seconds with 5% NaOH after cross sectioning and polishing.

In Fig. #8 there appears to be an area where the overlying enamel wedge has chipped and fractured, and in some cases been removed, during the polishing and etching procedure. In back of this zone, where the porcelain enamel becomes continuous, there is a thin, dark layer of material between the porcelain enamel and the aluminum. Whether this layer is of oxidic nature or is a surface layer on the alloy with a composition different from the main body of the alloy is undetermined.
